# OPERATION CROSSROADS

## BUREAU OF SHIPS INSTRUMENTATION GROUP

SECTION X

### Shock Measurements

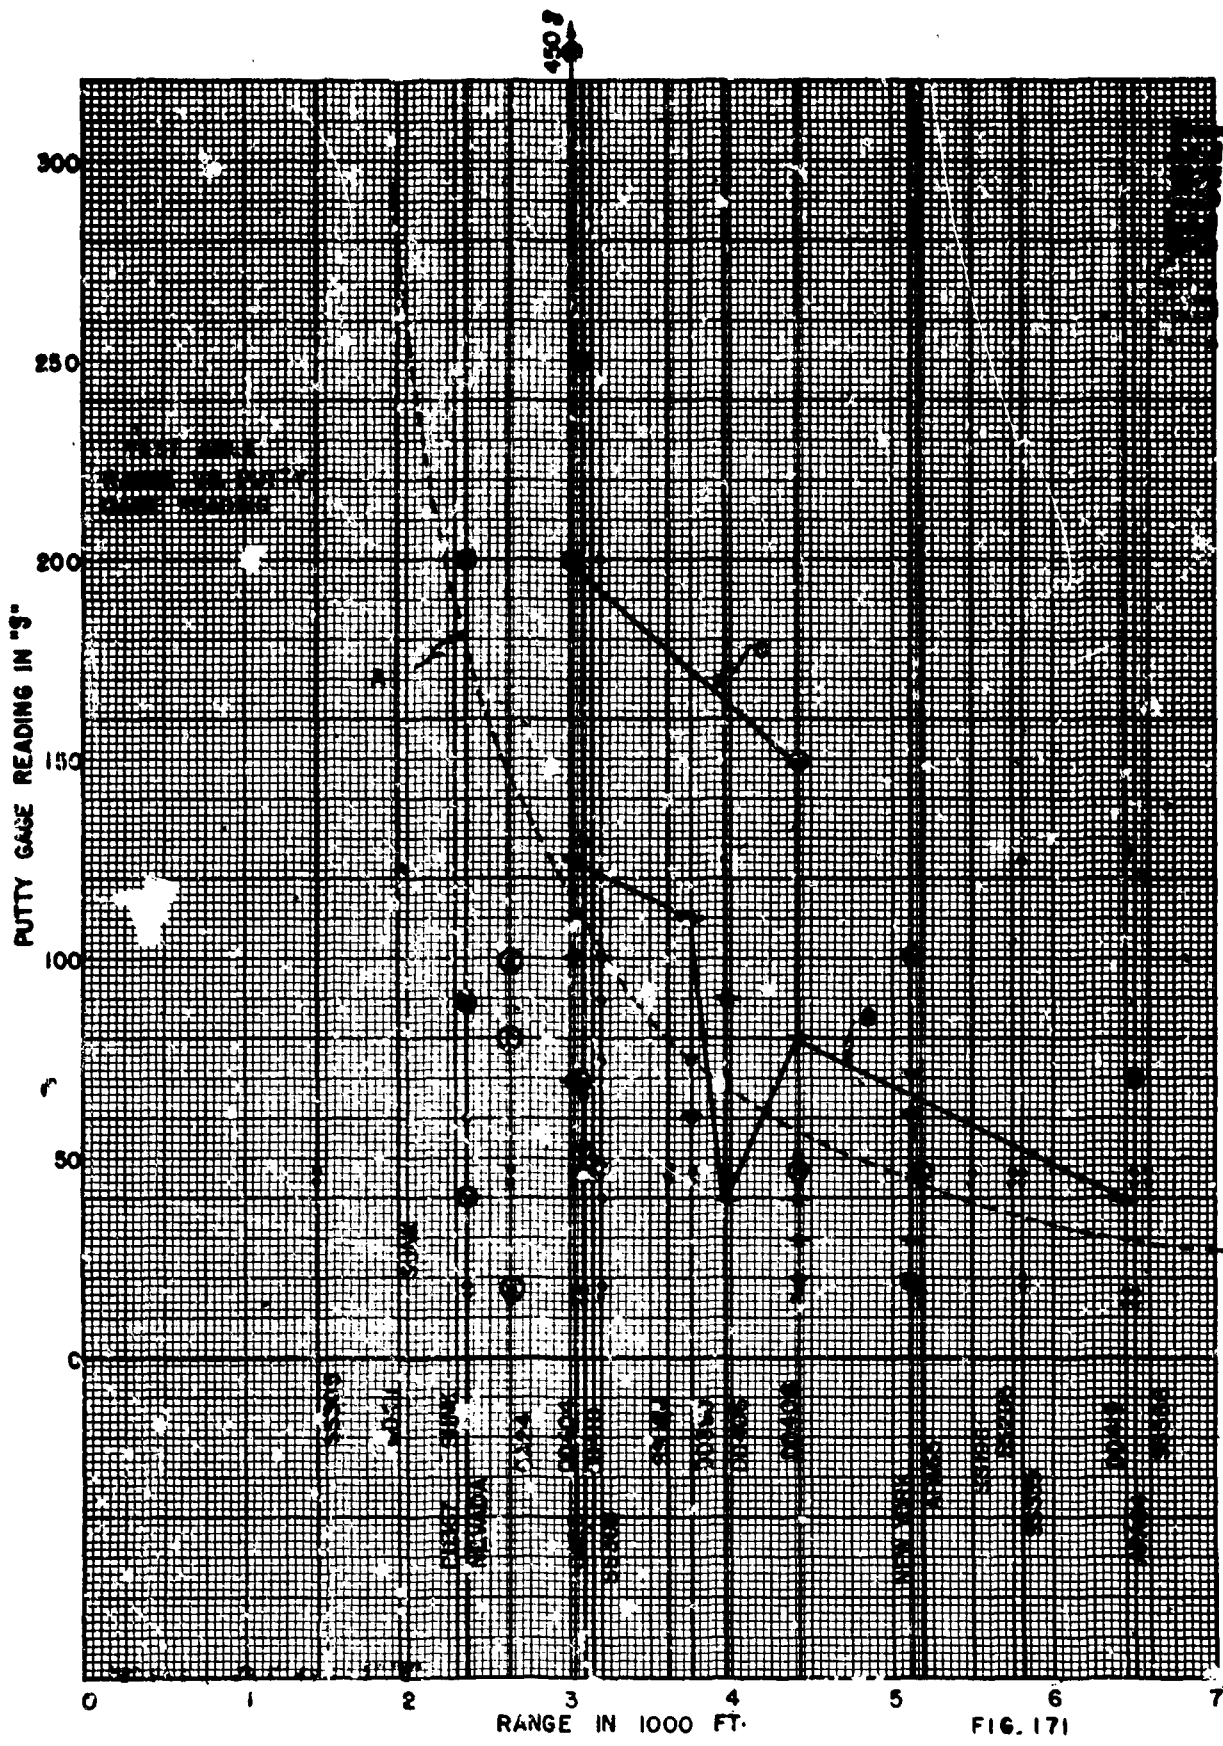
FIG. 171

A plot of putty gage readings versus range is shown in fig. 171. Gage readings from class (1) locations are represented by circled dots; class (2) locations, by horizontal bars through dots; and class (3) locations, by dots alone. A short arrow down from a point indicates that no reading was obtained on the gage and the point is placed at the minimum setting of the gage. The dotted curve "A" is copied from a peak

In figures 171 and 172, no emphasis should be placed upon whether points are concentrated in a region of high or low readings. The gages were placed largely in anticipation of Test Baker and their distribution did not necessarily reflect the distribution of equipment susceptible to shock.

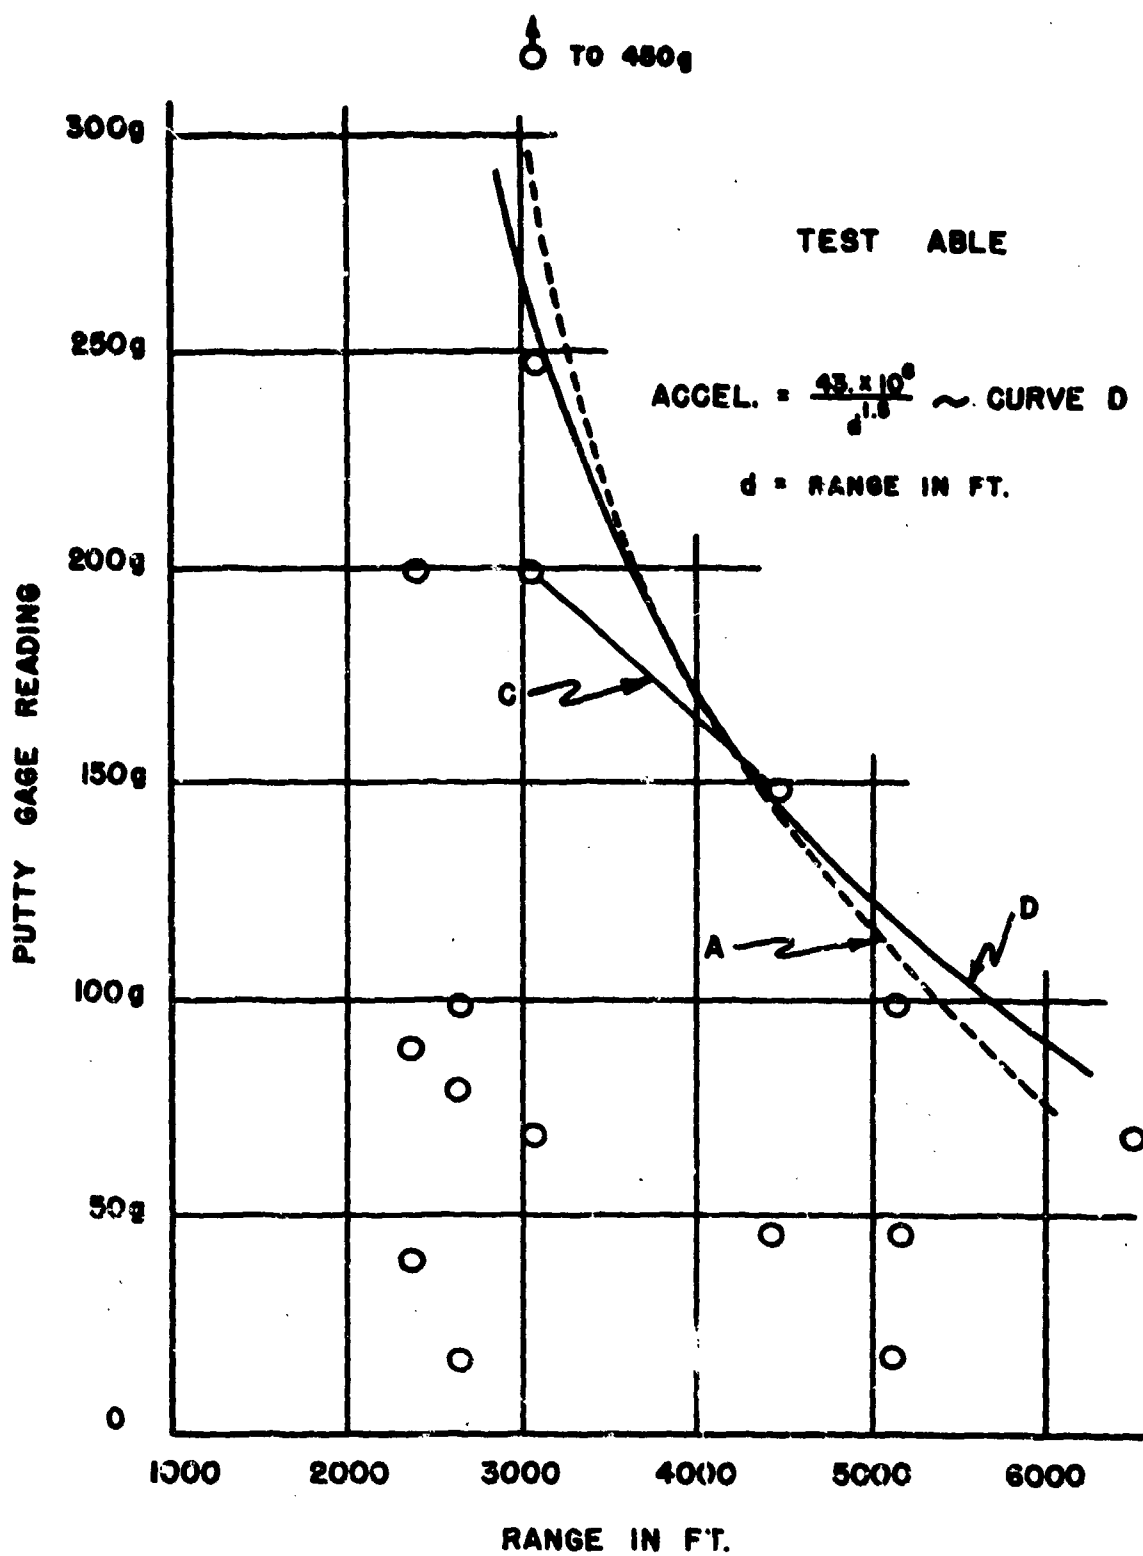
FIG. 171A

RANGE vs PUTTY GAGE READINGS FOR CLASS (I)  
LOCATIONS FOR ALL TYPES OF SURFACE SHIPS.

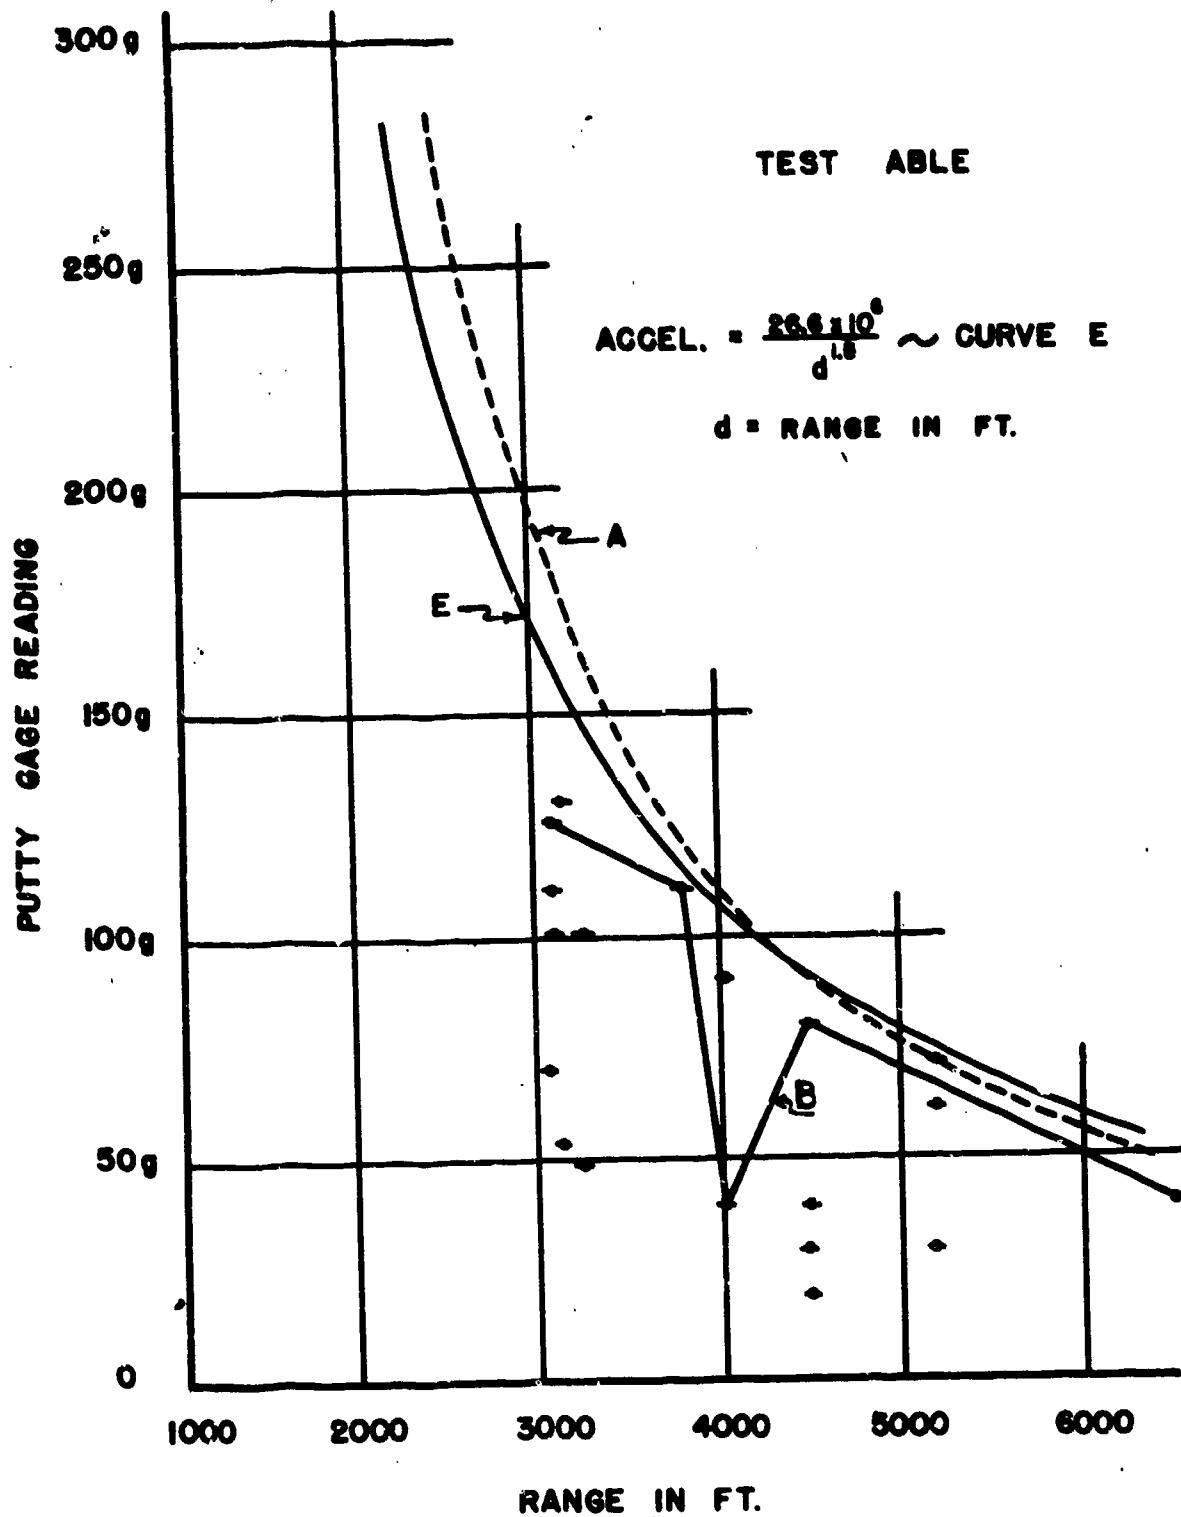
**FIG. 171 B**

Similarly, the plot of figure 171B shows only the points for class (2) locations and indicates that accelerations in units of gravity no greater than  $\frac{27 \times 10^6}{d^{1.5}}$  may normally be expected. Again it is noted that the maximum accelerations are approximately proportional to the peak pressure of the blast wave.

**RANGE vs PUTTY GAGE READINGS FOR CLASS (2)  
LOCATIONS FOR ALL TYPES OF SHIPS**

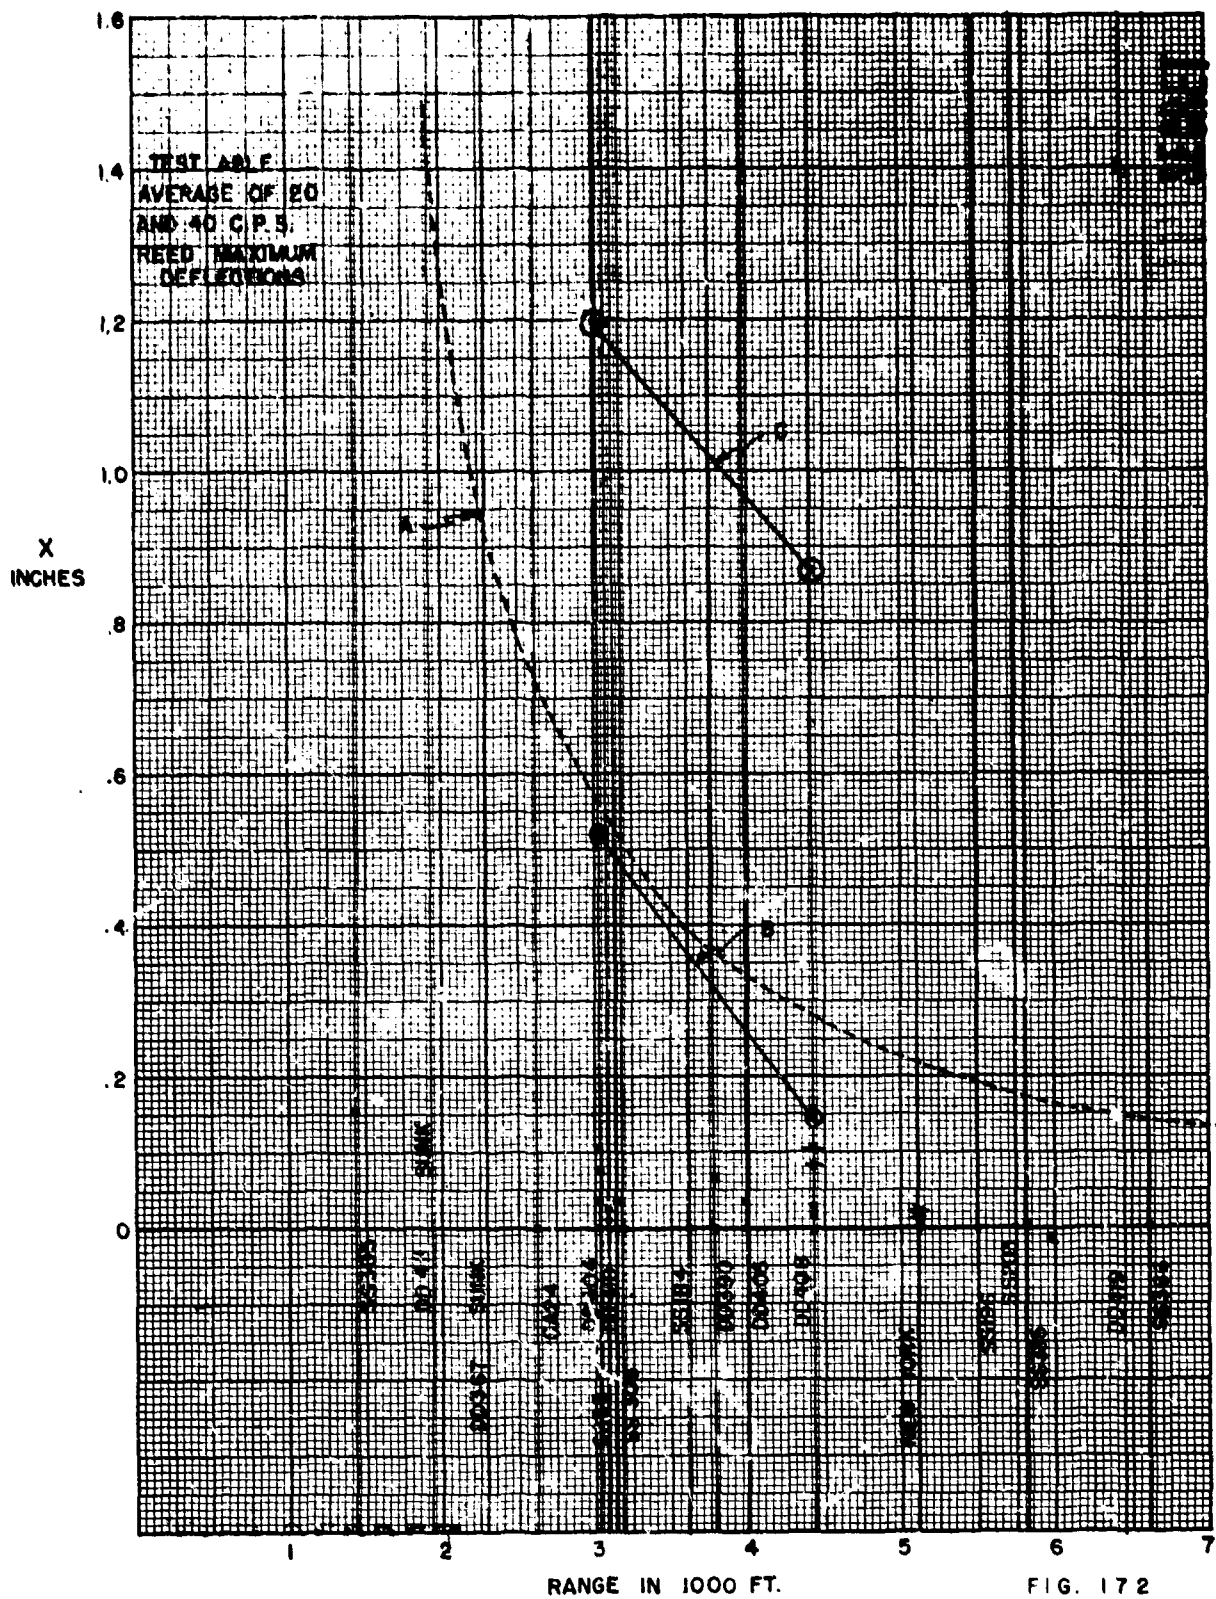
FIG. 172

A plot of "Average of 20 and 40 Cycle Reed Maximum Deflections" versus range is shown in figure 172. These values were computed by simple averaging in order to decrease deviations due to resonance of either a 20 or 40 cps reed. The values indicate the amount of distortion to be expected in low frequency structures. They indicate the deflection of an average shock mounted equipments in the mounts are linear for all deflections. The dotted curve "A" is a copy of a peak pressure versus distance curve. The line "B" connects points from the DD404 and DD408 gages on a hull frame 5 feet below the main deck. The line "C" connects points from the DD404 and DD408 gages on the external supply office bulkhead. From line "C" the "response" or deflection of the 20 to 40 cps. reeds may be estimated to be between 0.8 and 1.5 inches for external bulkheads of destroyer superstructures which were dished in several inches for the lower values and ruptured for the higher values. The response on light hull frames above the waterline, as indicated by line "B", will be up to 0.5 inches for low frequency reeds. Low frequency reed deflections for interior parts of the ship, class (3) are generally less than 0.1 inch for distances greater than 3000 feet from the explosion.

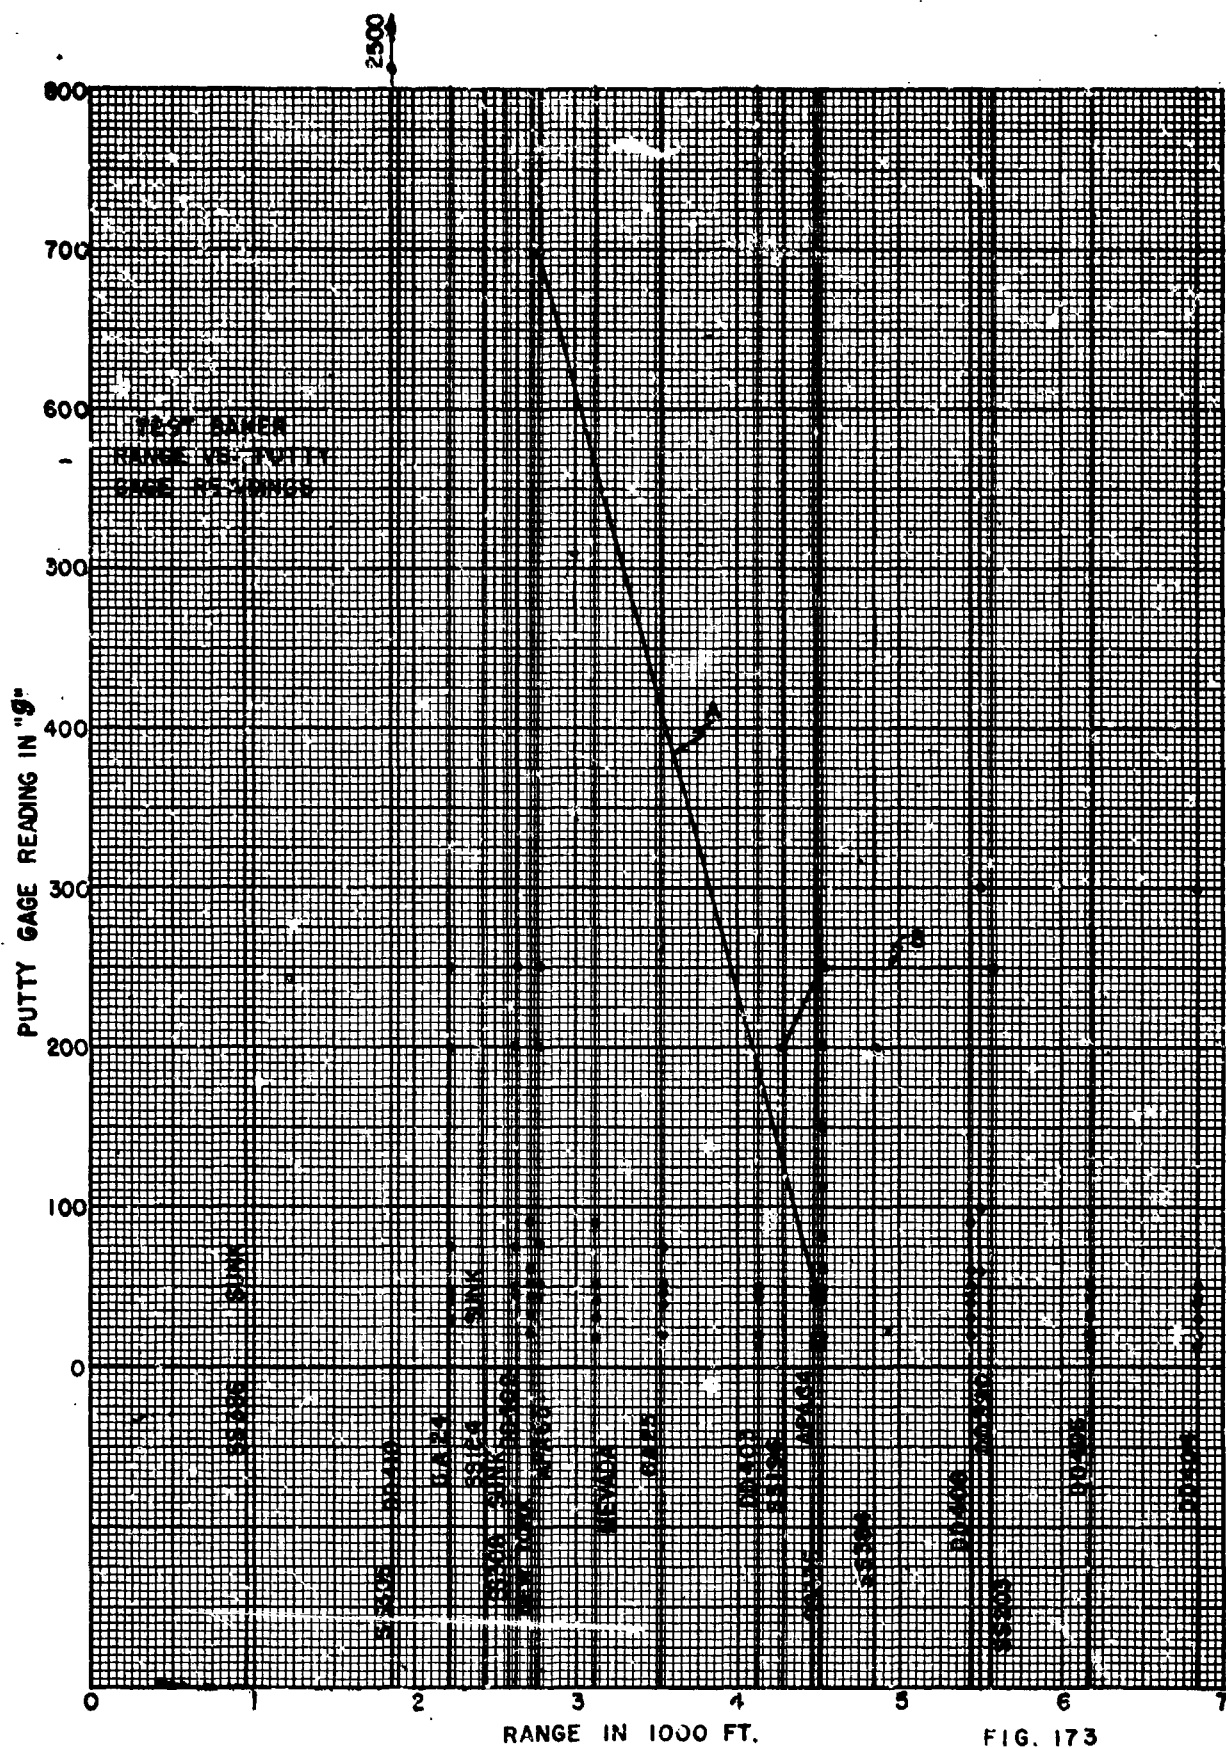
FIG. 173

The putty gage and the low-frequency reed readings have been plotted as in Test Able. Referring to figure 173, it is seen that the putty gage readings on hull frame members nearest to the explosion stand out far above the other readings. The SS305 reading of 2500g., the APA65 reading of 700g., the SS384 reading of 200g. and the three submarine readings connected by line B represent the only putty gage locations on hull frame members with an angle of incidence of the initial pressure pulse of over, say, 15° and their angles of incidence were all over 60°. The line A connects readings of identical portside hull frame locations below the waterline on the APA's 65 and 64. The explosion was to port of the APA 65 and to starboard of the APA64. For a different orientation of the ships the upper limit of gage readings is indicated by the few high readings.
